With reference to: periodic salt spray test

Tritech sample number	2015-03567
Specimen	antennas
Specification	DIN EN 60068-2-52 (October 1996)
Code	severity level 1

Test Report

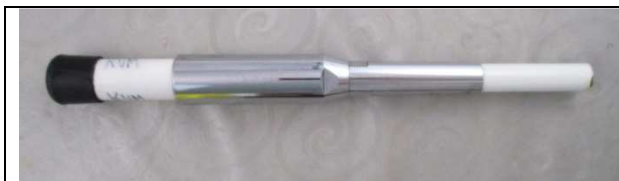
Sample "KUM" after four cycles salt spray test

At no time the sample shows any changes of the surface. The sample has no blisters or cracks. The surface is free of deposits of corrosion products.

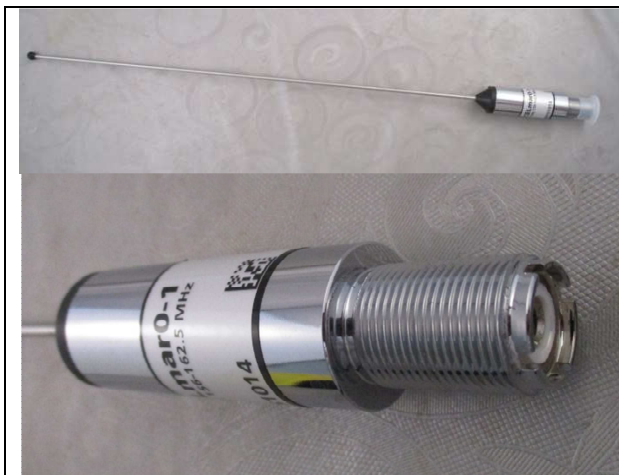
Sample "CELmar" after four cycles salt spray test

After four cycles salt spray test the surface of the sample is free of any changes. No blisters, cracks or corrosion products can be recognized at the sample.

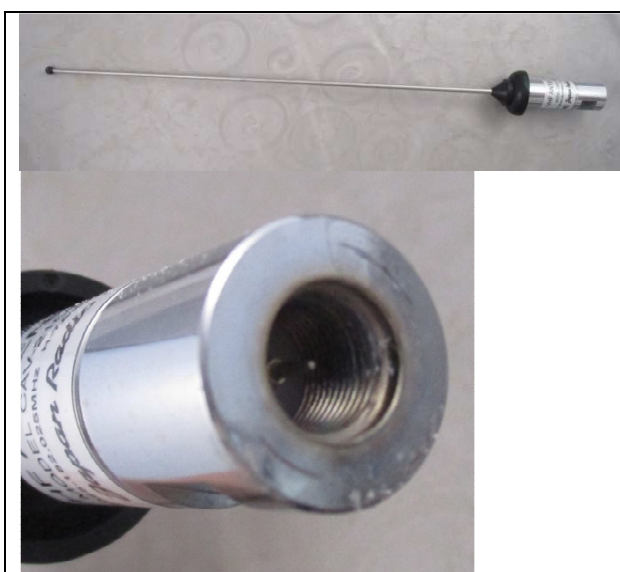
Sample "H7ABJD00027" after four cycles salt spray test

After three cycles salt spray test shows the sample little white stains at the thread.

The stains at the thread did not increase after the fourth cycle salt spray test. At the remaining surface no changes can be seen. The sample is completely free of blisters, cracks and corrosion products.

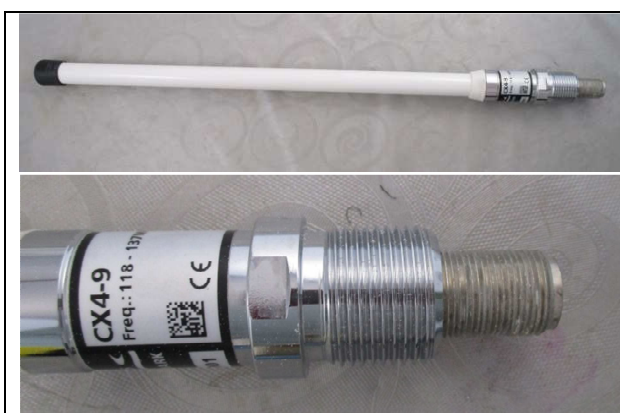
Sample "CX4" after four cycles salt spray test

The sample shows no changes after the first three cycles salt spray test.

After four cycles salt spray test beginning white deposits can be seen at the smaller thread. There are no changes of the remaining surface of the sample. The coating of the sample has no blisters or cracks.
