With reference to: periodic salt spray test

Tritech sample number **2015-03567**
Specimen **antennas**
Specification **DIN EN 60068-2-52 (October 1996)**
Code **severity level 1**

Test Report

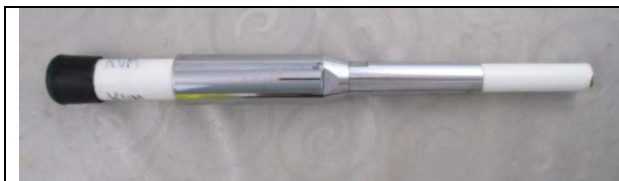
Sample "KUM" after four cycles salt spray test

At no time the sample shows any changes of the surface. The sample has no blisters or cracks. The surface is free of deposits of corrosion products.

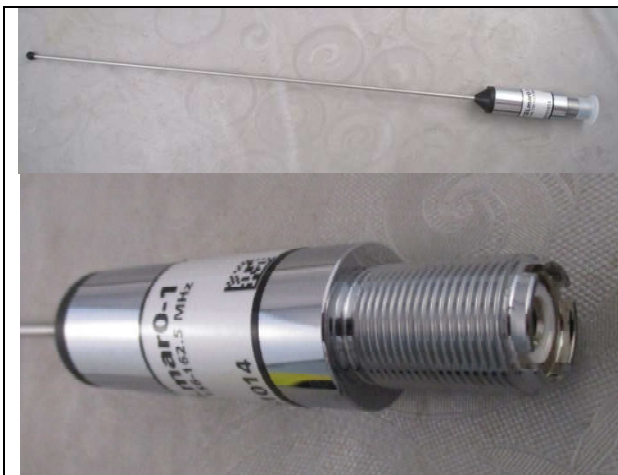
Sample "CELmar" after four cycles salt spray test

After four cycles salt spray test the surface of the sample is free of any changes. No blisters, cracks or corrosion products can be recognized at the sample.

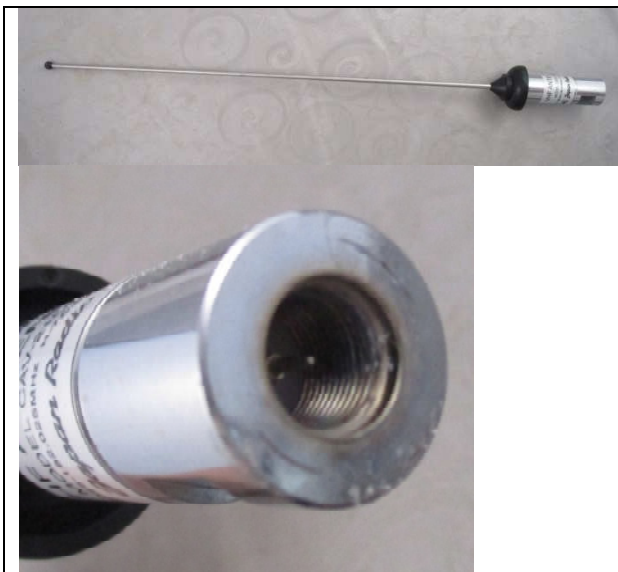
Sample "H7ABJD00027" after four cycles salt spray test

After three cycles salt spray test shows the sample little white stains at the thread.

The stains at the thread did not increase after the fourth cycle salt spray test. At the remaining surface no changes can be seen. The sample is completely free of blisters, cracks and corrosion products.

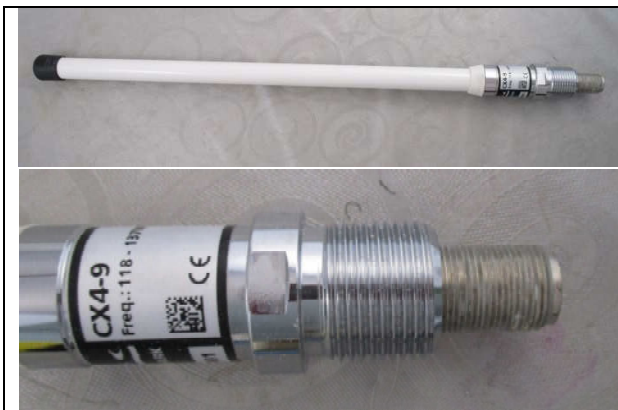
Sample "CX4" after four cycles salt spray test

The sample shows no changes after the first three cycles salt spray test.

After four cycles salt spray test beginning white deposits can be seen at the smaller thread. There are no changes of the remaining surface of the sample. The coating of the sample has no blisters or cracks.
